No. 020/2024

16 January 2024

Post Office Ltd Estate - Reinforced Autoclaved Aerated Concrete (RAAC):

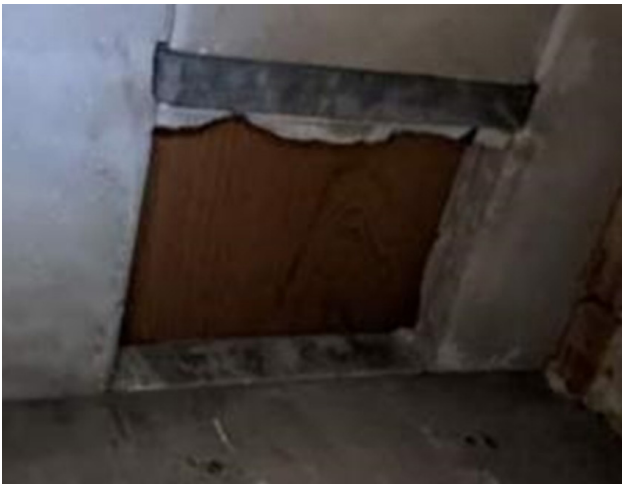
Original construction techniques used narrow steel trimmers or hangers supported by adjacent panels to form openings in roofs. These steel hangers often have narrow bearing support and have been installed some distance from transverse reinforcement. Therefore, cut panels supporting on hangers present inadequate bearing conditions and poorly anchored longitudinal reinforcement.

Figure 4 – Photo of hangers

Depending on the span of the panel being supported these conditions may present high risk of panel failure.
